# Orla

# Technical expertise

## **EKSPERTYZA TECHNICZNA** z oceną stanu mykologicznego budynku

**Budynek zabytkowej synagogi**  
(wpisany do rejestru zabytków pod nr A-411)

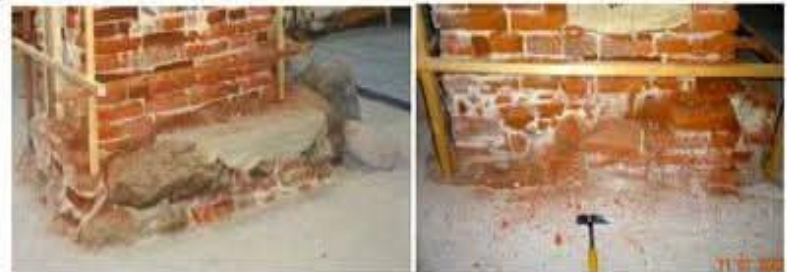
Fot.30 Uszkodzona podstawa filara Nr2 ....

... i filara Nr3

1. Wykonać doraźną reperację podstawy filarów Nr 1-4 (oznaczenie na rzucie parteru – Załącznik Nr 1 do niniejszej ekspertyzy) za pomocą cegły pełnej, czerwonej, o wytrzymałości na ściskanie min. 12 MPa i zaprawy cementowo-wapiennej marki min. 5MPa. Zachować oryginalne wymiary obrysu.

1. Repair of the base of the pillars with solid, red brick and cement-lime mortar;
2. Repair the gap in the roof;
3. Repair of vertical and diagonal wall stratifications of the structural wall. Works should be done from the inside and outside to the depth of one brick;
